INDOOR AIR QUALITY ASSESSMENT

**Barnstable United Elementary School
730 Osterville W. Barnstable Road
Marstons Mills, Massachusetts**

Prepared by:
Massachusetts Department of Public Health
Bureau of Environmental Health
Indoor Air Quality Program
October 2019

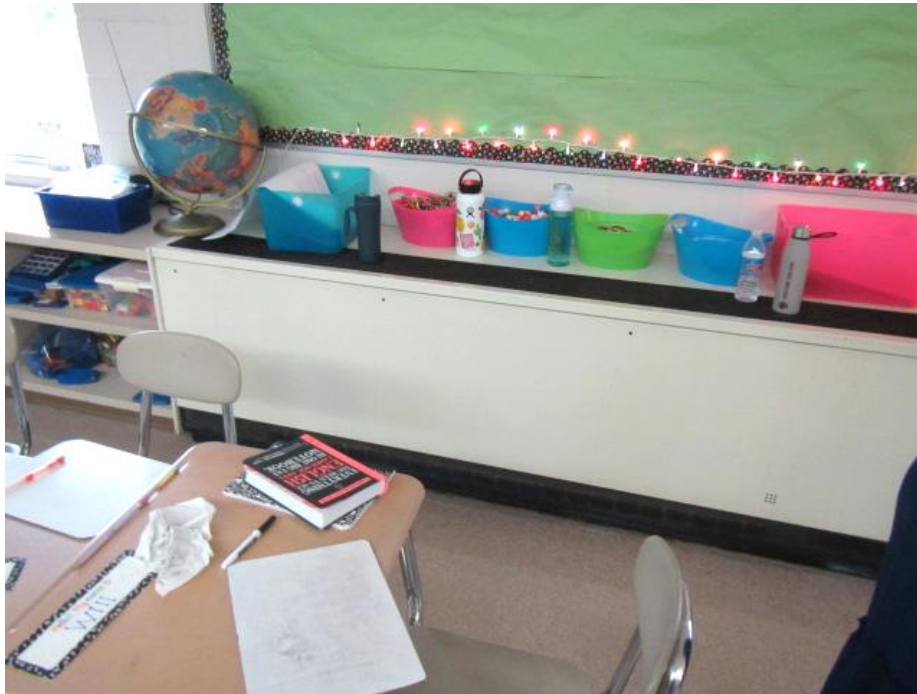
Picture 1

Fresh air in classrooms is supplied by unit ventilators (univents, Picture 1). Univents draw air from the outdoors through a fresh air intake located on the exterior wall of the building (Picture 2) and return air through an air intake located at the base of the unit. Fresh and return air are mixed, filtered, heated or cooled and provided to rooms through an air diffuser located in the top of the unit ([Figure 1](#)). In room 205 the univent was reportedly inoperable; therefore no fresh air was being introduced at the time of testing. In addition, in some rooms the top and/or front of some univents were blocked by classroom items (Picture 3). In order for univents to provide fresh air as designed, intakes/returns must remain free of obstructions. Importantly, these units must remain on and be allowed to operate while rooms are occupied. It is also important to note that outside air is typically limited (by pneumatically adjusting intake louvers) during air conditioning (AC) season and cold/winter months to provide comfort and prevent the freezing of pipes.

Classroom univent

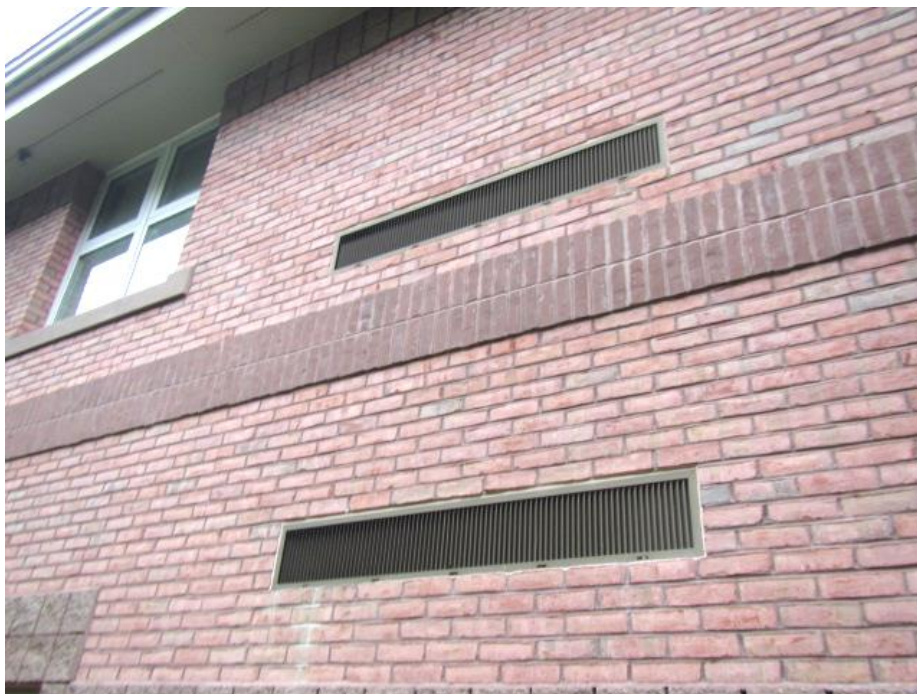
Picture 2

Univent fresh air intakes

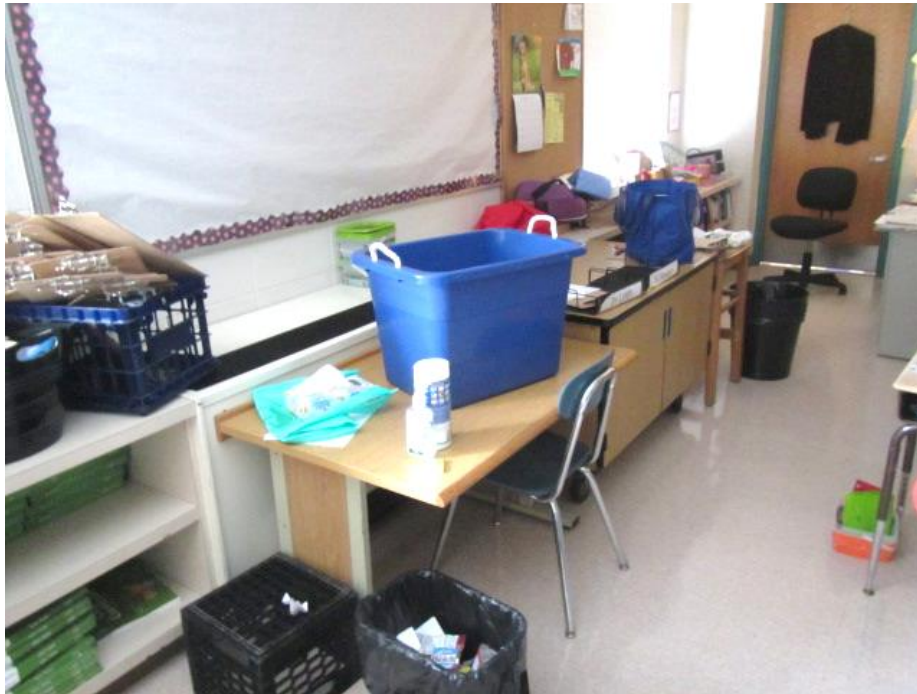
Picture 3

Univent return vent (bottom front) obstructed by classroom furniture

5. Remove furniture and items blocking the front and top of univents.
6. Periodically assess whether exhaust vents (classrooms and restrooms) are drawing air and make repairs as needed.

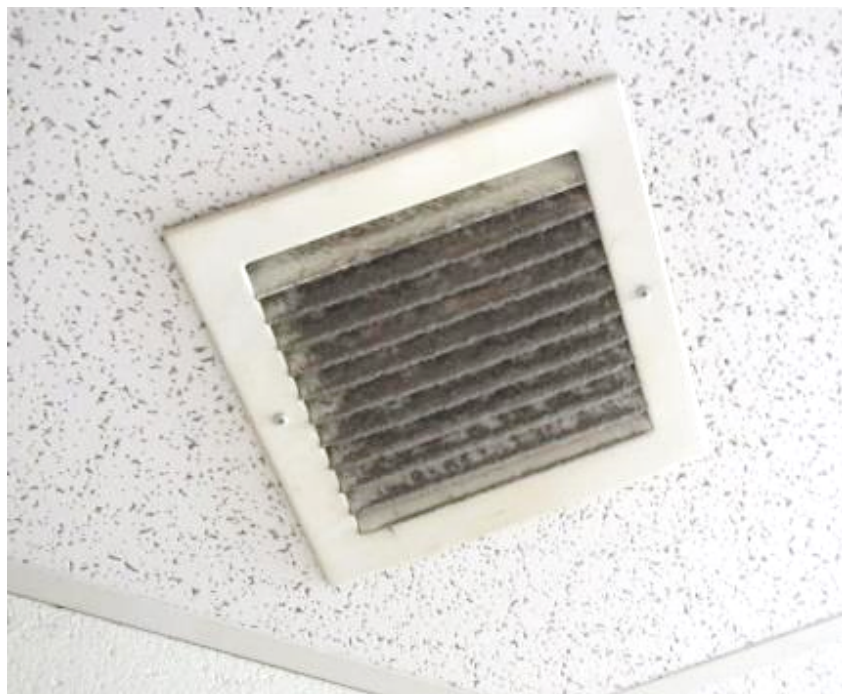
Picture 4

Classroom exhaust vents are located in the ceilings (Picture 4) and are connected with ducts to exhaust fans on the roof. A number of these exhaust vents were not drawing air during the assessment. Note that in many classrooms, exhaust vents were located near classroom doors (Picture 5). This design works best with the doors to the hallway closed, otherwise the exhaust vents tend to draw air from the hallway rather than the room which reduces the effectiveness of air circulation. Without adequate supply and exhaust ventilation, excess heat/humidity and environmental pollutants can build up and lead to indoor air/comfort complaints.

Classroom exhaust vent, note accumulated dust/debris

20. Consider using disposable, pleated cardboard filters instead of filter media that needs to be hand cut and installed in metal racks.
21. Clean supply/exhaust vents and personal fans regularly to remove accumulated dust/debris. Replace surrounding ceiling tiles that cannot be adequately cleaned.

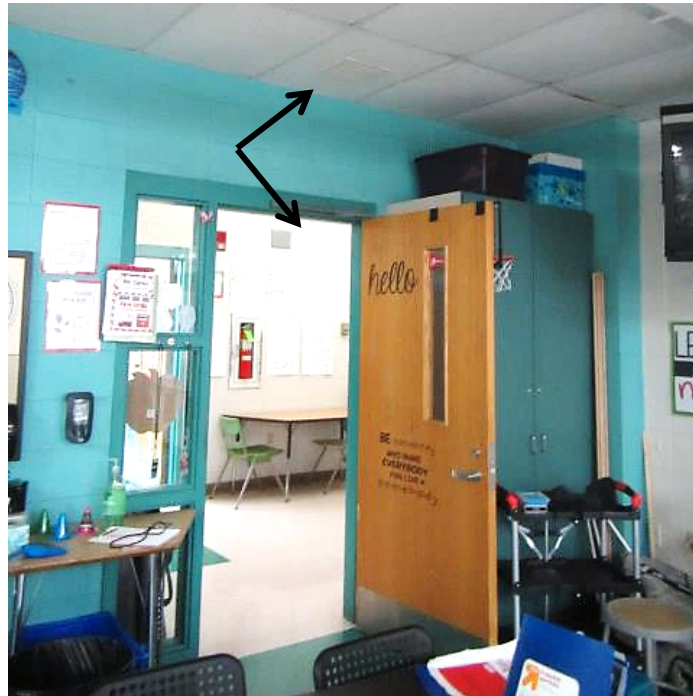
Picture 5

Proximity of classroom exhaust vent (arrows) to open hallway door

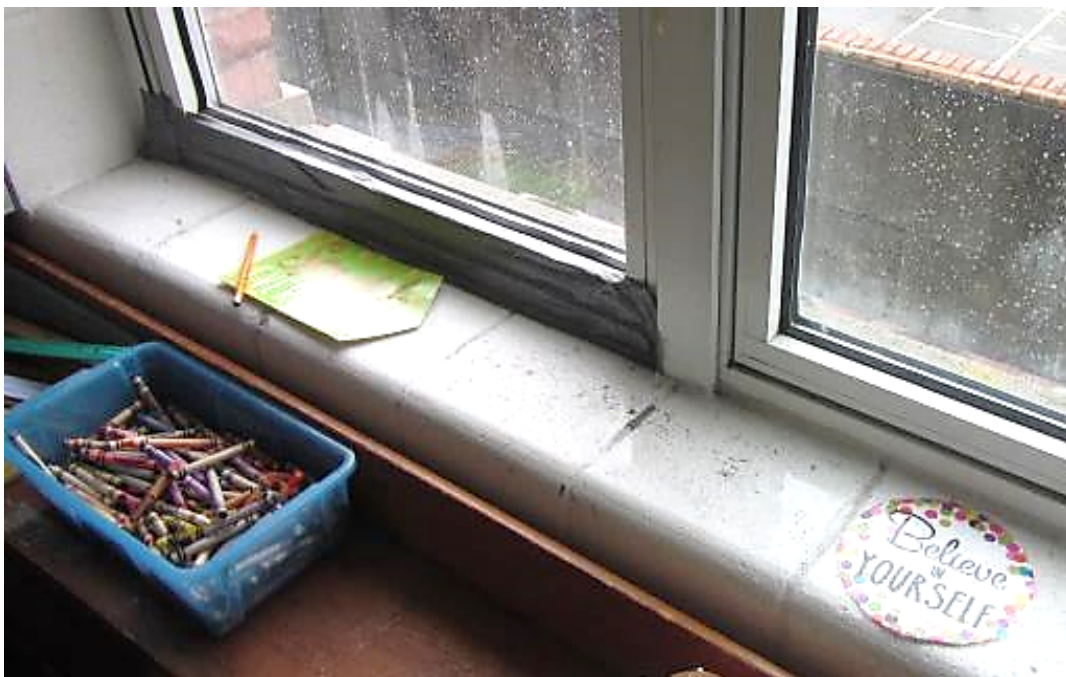
Picture 6

In order for building materials to support mold growth, a source of water exposure is necessary. Identification and elimination of the source of water moistening building materials is necessary to control mold growth. In the case of the BUES, the main sources of moisture creating conditions conducive to mold growth are relative humidity and operation of the AC system. However other sources of water damage are typically present in most buildings such as roof/window leaks (Picture 6) as well as leaks/condensation from HVAC systems and plumbing.

Standing water from active leak on masonry/windowsill in classroom 215, note duct tape on left window

12. Work with a roofing contractor/building engineer to investigate/repair building envelope leaks (e.g., 2nd floor hallway/windows in Room 215). Until this has been completed, avoid storing porous materials in areas of known leaks.

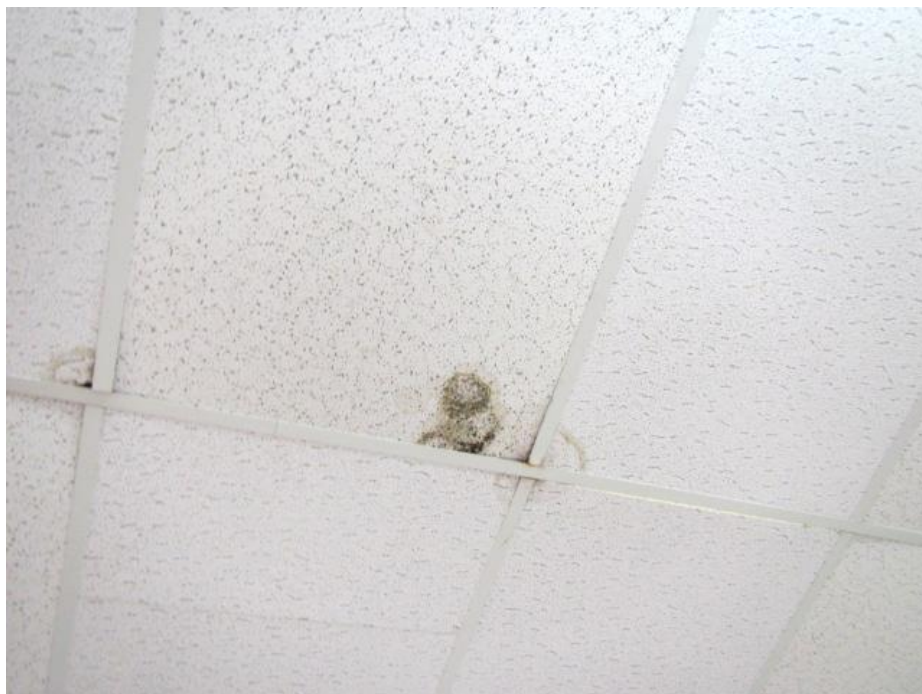
Picture 8

Water-damage/mold growth on ceiling tiles room 219

13. Once repairs are made, replace water-damaged ceiling tiles and refinish areas of water damage. Inspect the area above the stained tiles for water damage or odors and remediate or clean as necessary.

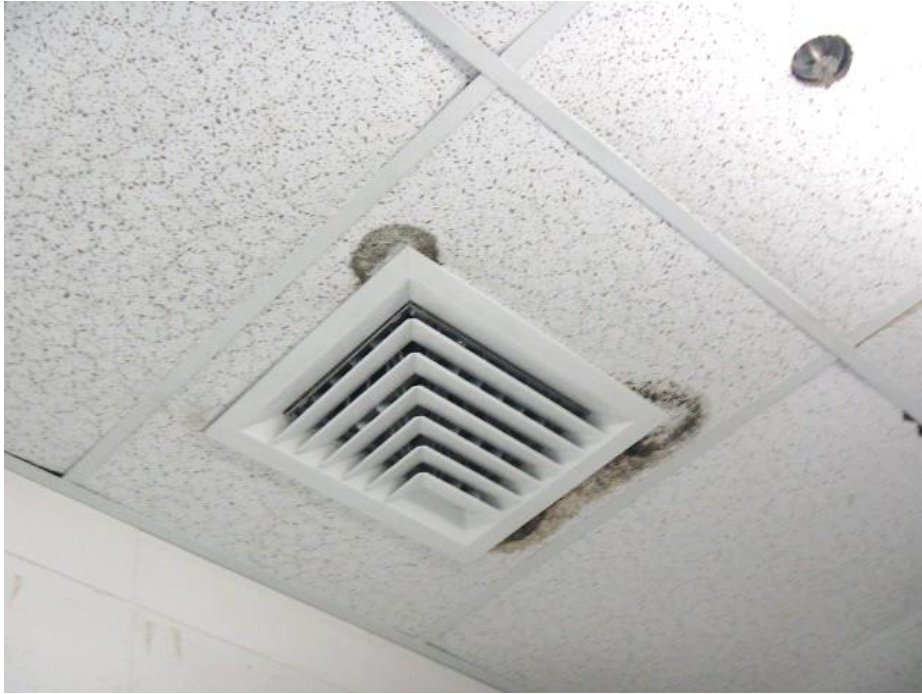
Picture 9

Water-damage/mold growth on ceiling tiles room 107

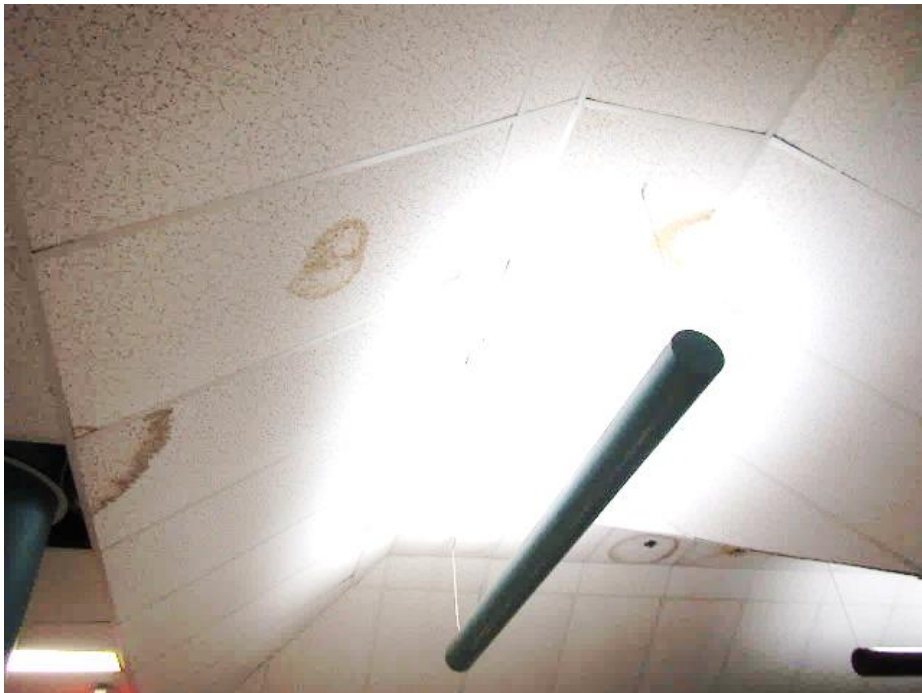
Picture 10

Water-damaged ceiling tiles in 2nd floor hallway near Room 217

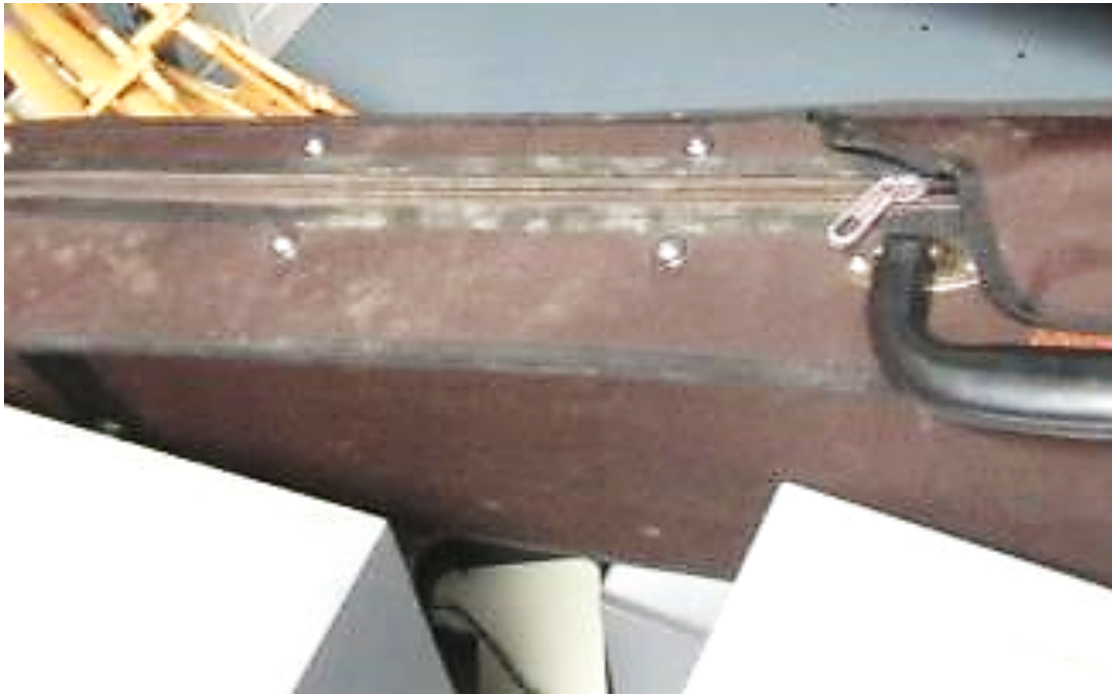
Picture 11

Mold growth on instrument case in band storage room

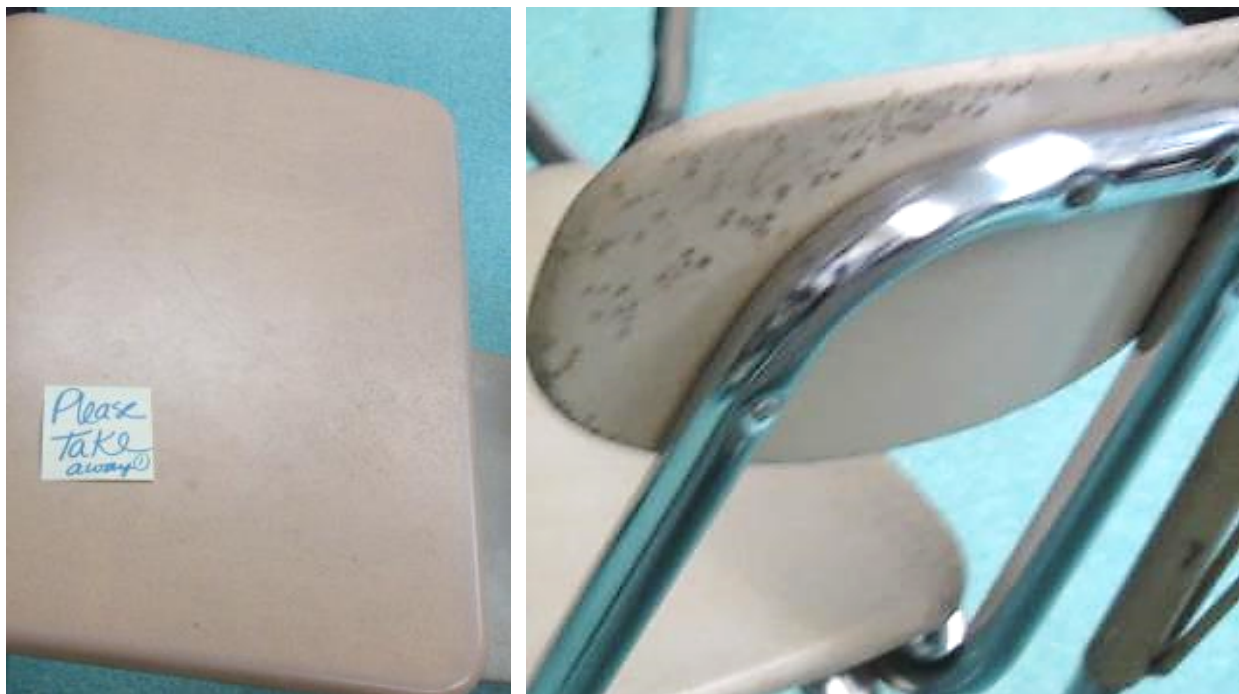
Pictures 12a and 12b

Mold growth on chair/desk unit labeled "Please Take away"

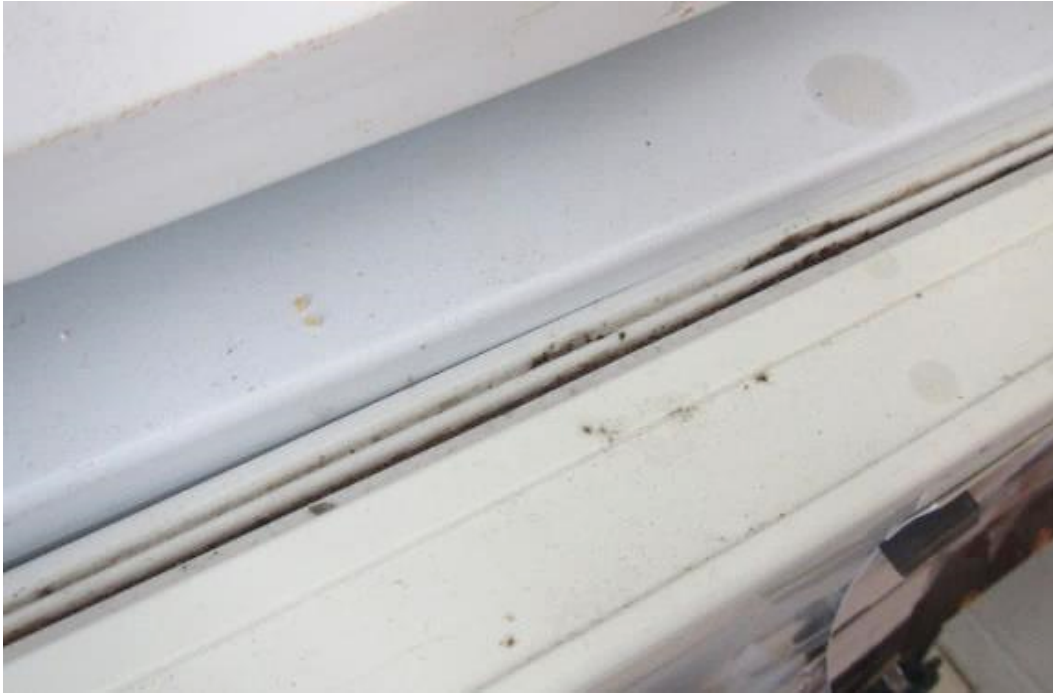
Picture 13

Debris/mold growth on mini-fridge gasket in classroom

22. Ensure all refrigerators are kept clean to prevent microbial growth and odors. Clean gaskets and other surfaces with a mild antimicrobial solution to remove debris and mold. If cannot be adequately cleaned-replace.

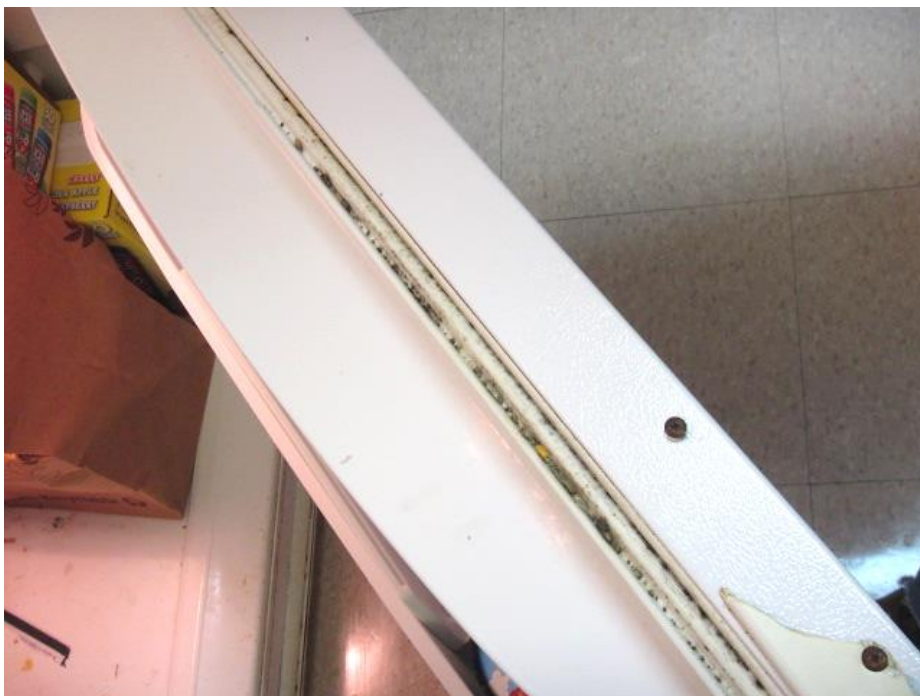
Picture 14

Debris/mold growth on mini-fridge gasket in Faculty Lounge

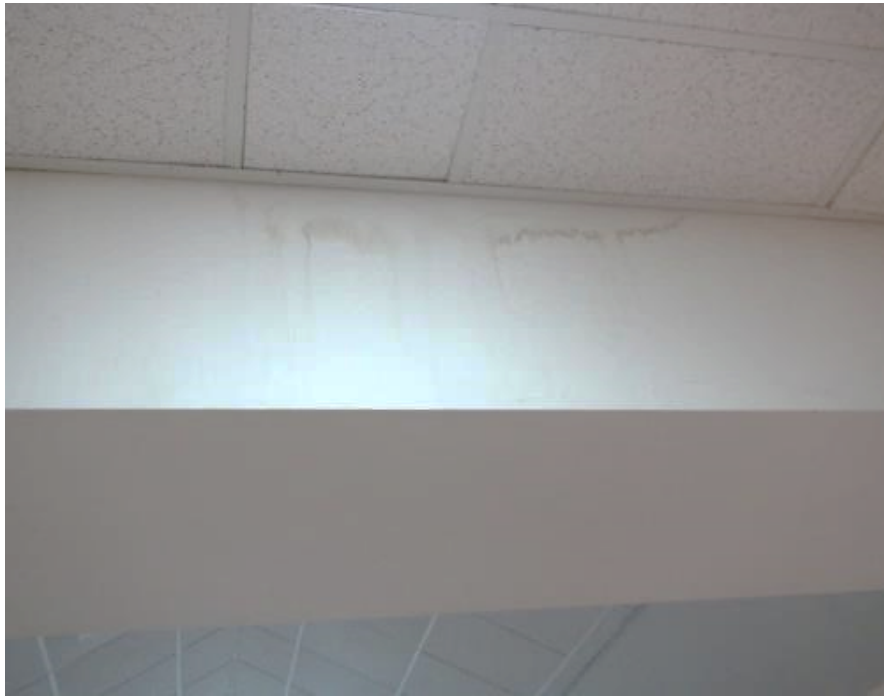
Picture 15

Water-stained gypsum wallboard outside Library

27. Repair/replace all water-damaged/mold-colonized porous building materials (e.g., ceiling tiles, gypsum wallboard) in classrooms, hallways and common areas in a manner consistent with the U.S. Environmental Protection Agency's guidelines (US EPA, 2008).

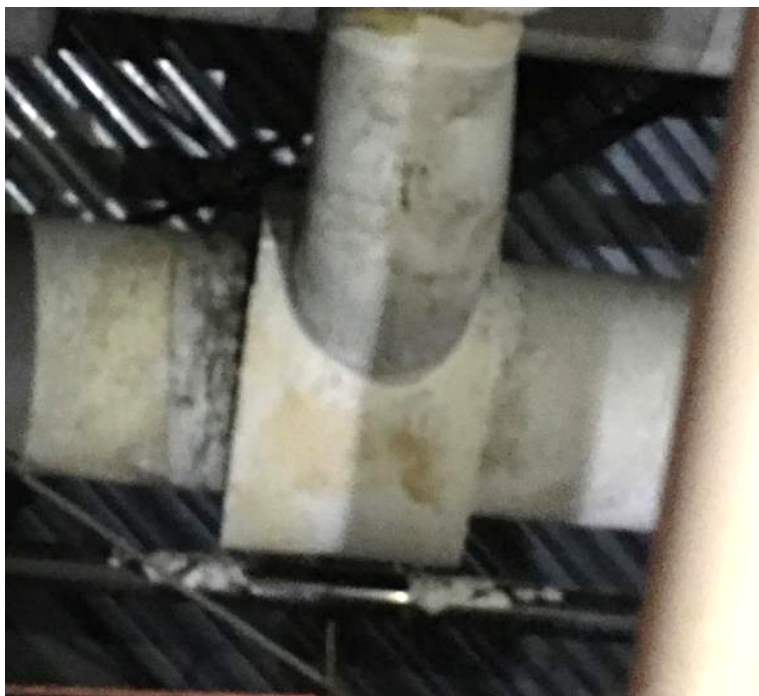
Picture 16

Insulation material in art room closet

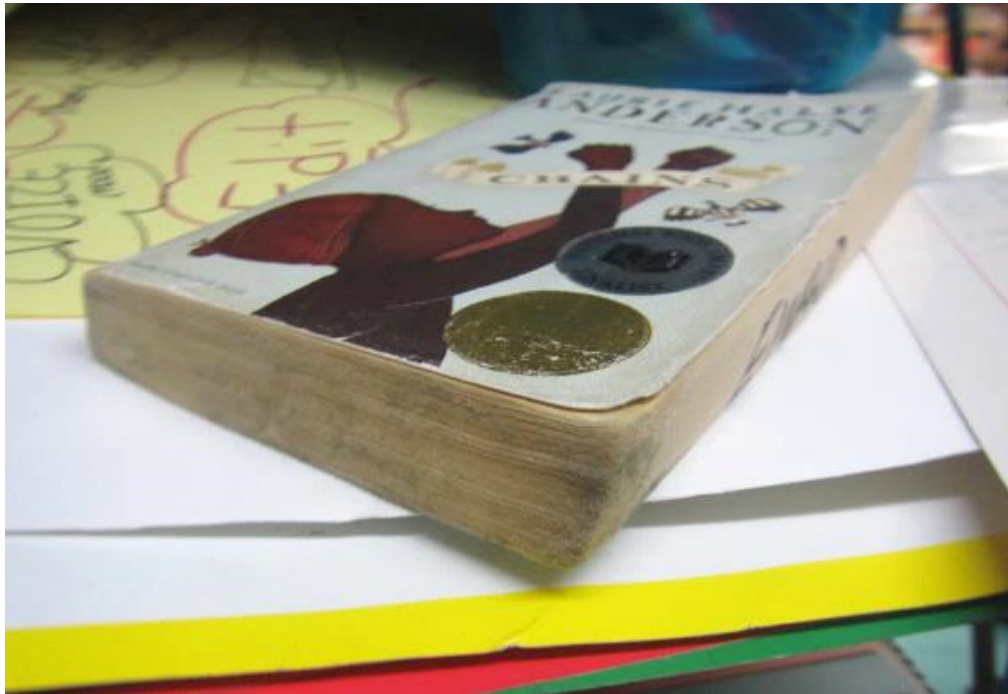
Picture 17

Mold growth on book in closet in Room 207

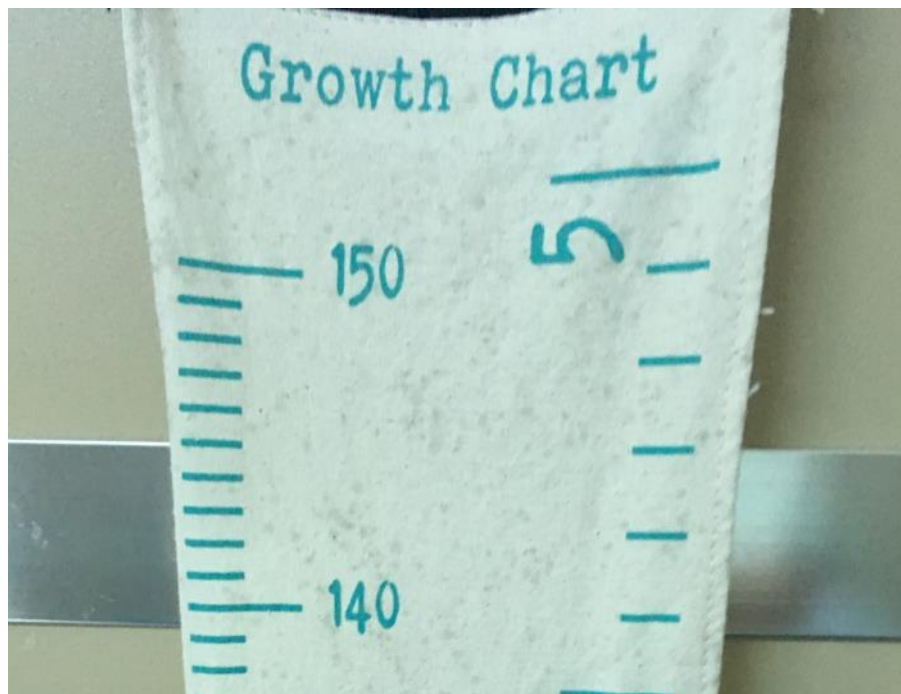
Picture 18

Staining from mold growth on fabric classroom item

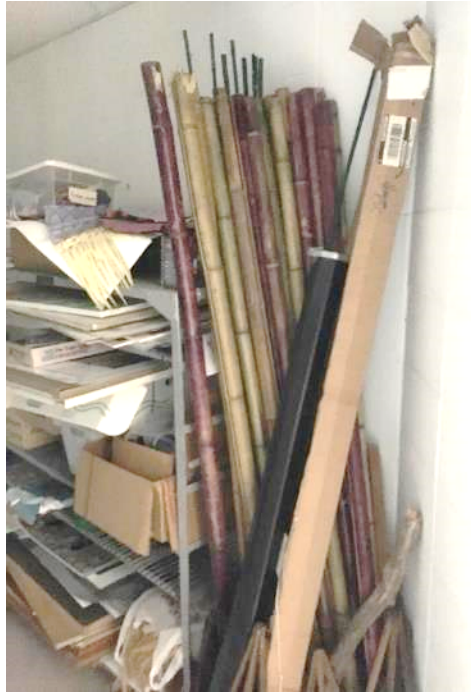
Picture 19

Moldy/odorous bamboo in Art room closet

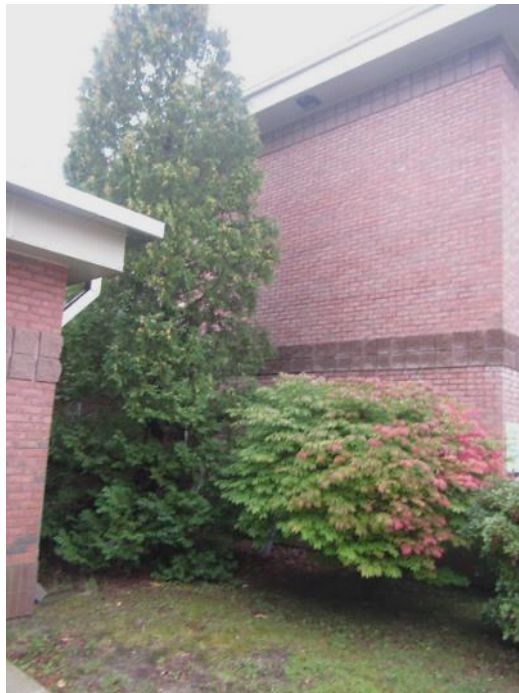
Picture 20

Trees/shrubbery in close contact with exterior walls

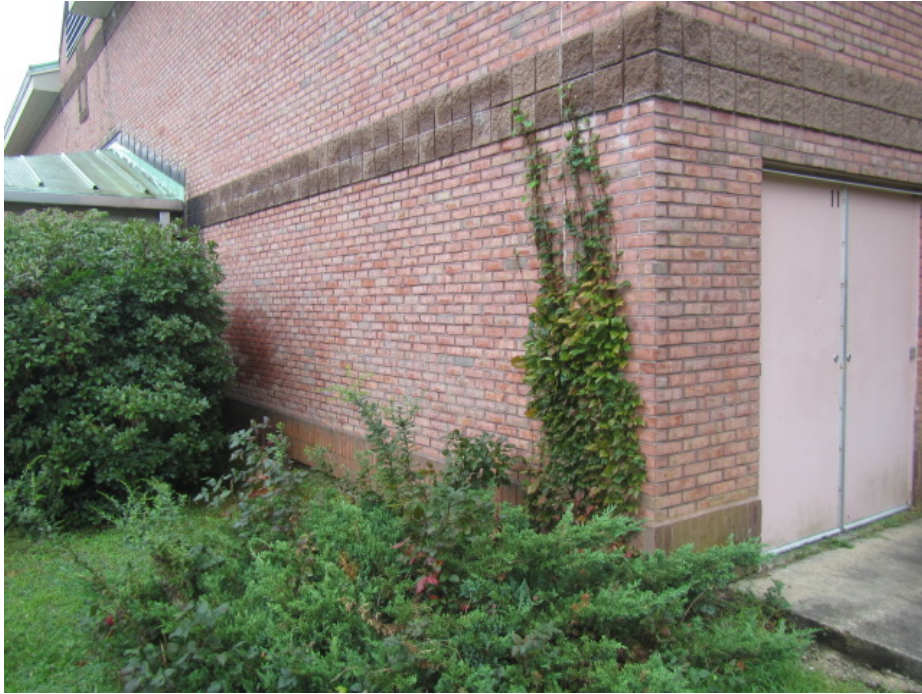
Picture 21

Trees/shrubbery in close contact with exterior walls, also note clinging plants

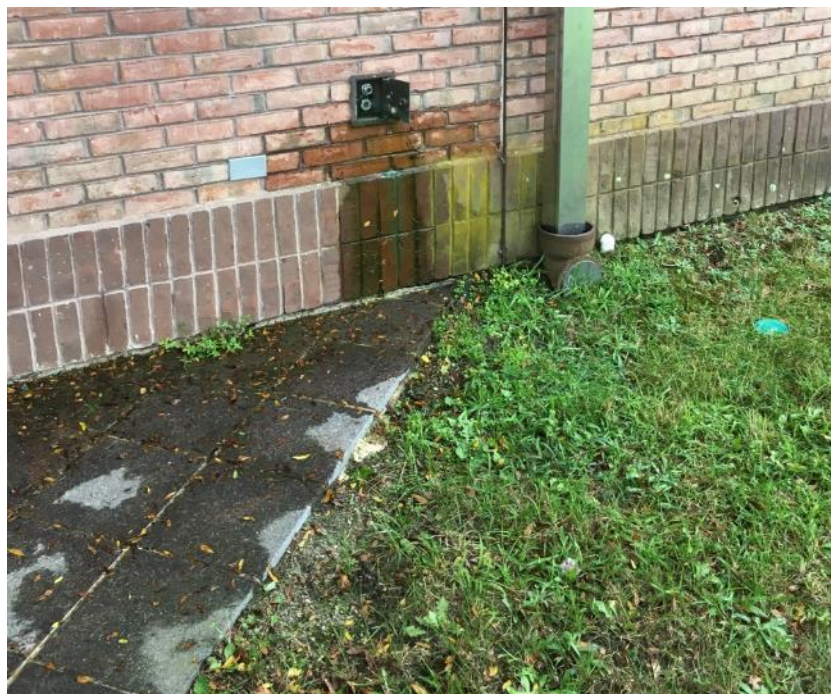
Picture 22

Leaking plumbing fixture

25. Fix plumbing leak shown in Picture 22.
26. Continue to utilize portable dehumidifiers as needed during excessive relative humidity periods (>70%). Ensure dehumidifiers are cleaned/maintained as per the manufacturer's instructions to prevent mold/bacterial growth.

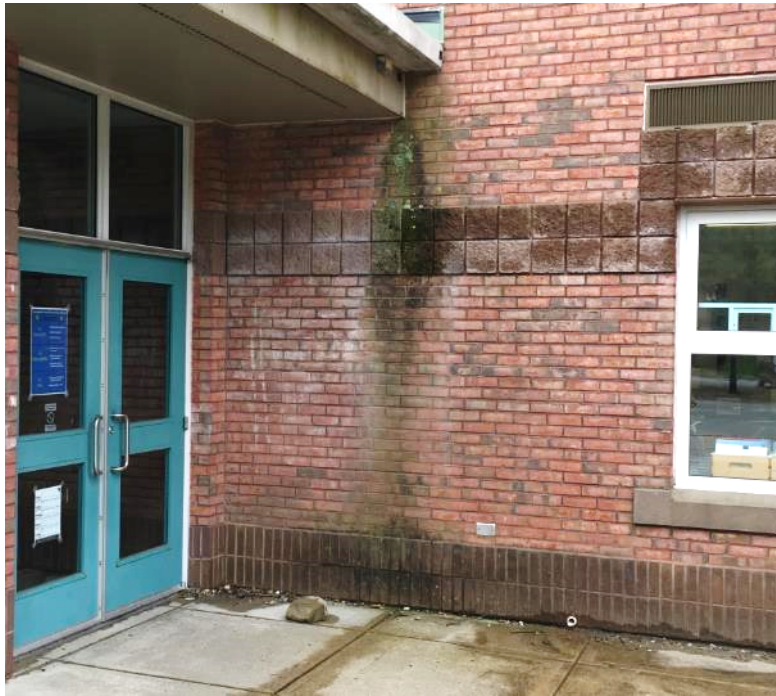
Picture 23

Moss growth from chronic water exposure on exterior walls

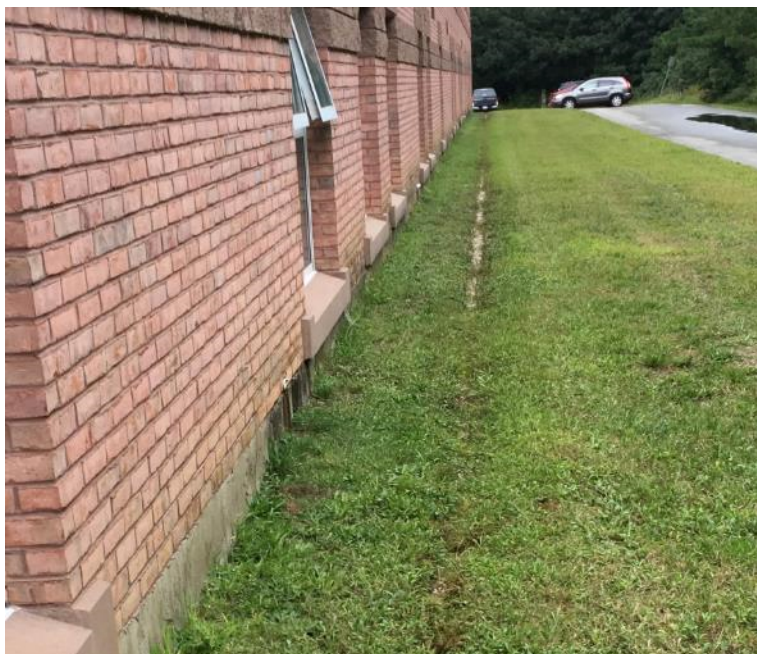
Picture 24

Trough along exterior of building due to roof runoff/lack of gutters, also note open classroom window while AC system operating

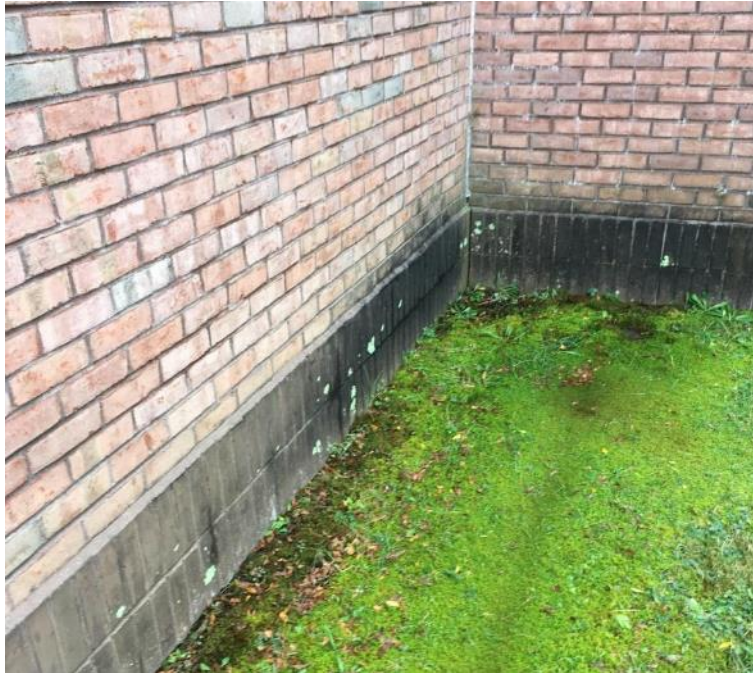
Picture 25

Over time, these conditions can undermine the integrity of the building envelope and provide a means of water entry into the building via capillary action through foundation concrete and masonry (Lstiburek & Brennan, 2001). The freezing and thawing action of water during the winter months can create cracks and fissures in the foundation. These breaches may provide a means for moisture and pests to enter the building.

Heavy moss growth/discoloration of foundation due to chronic water exposure (i.e., splash back) from lack of drainage/gutters/downspouts

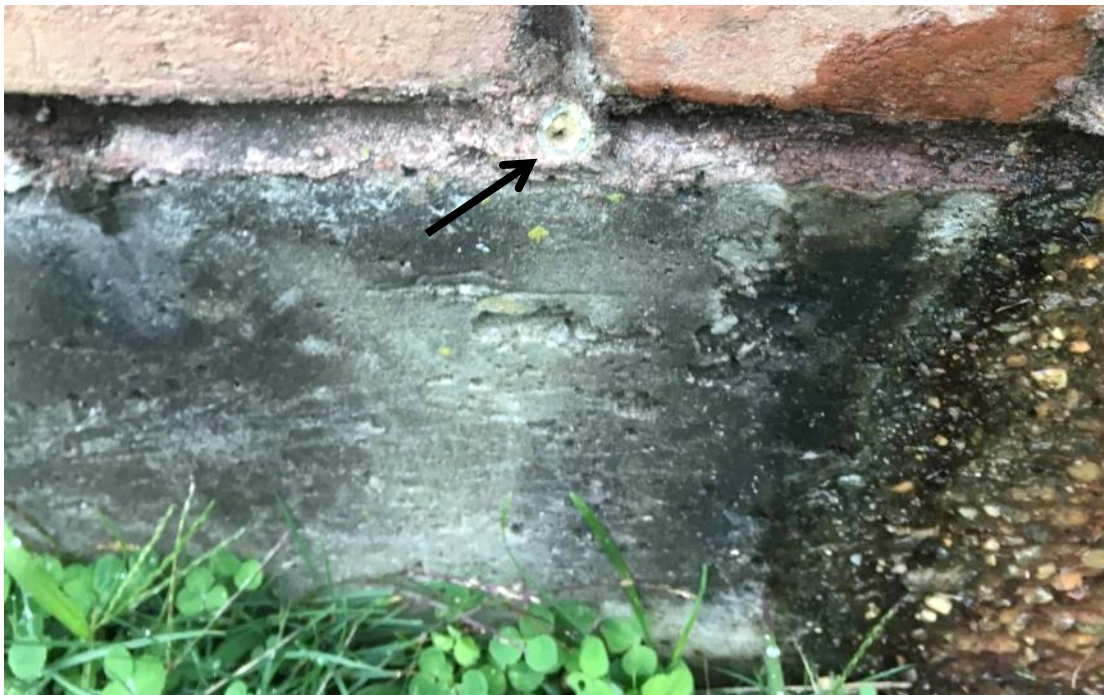
Picture 26

During the exterior examination MDPH/IAQ Program staff also noted exterior wall drainage hindered by clogged/plugged weep holes (Pictures 26 and 27). In modern construction, brick exterior wall systems are usually designed to prevent moisture penetration into the building interior. An exterior wall system usually consists of an exterior brick curtain wall ([Figure 2](#)). Behind the curtain wall is an air space that allows for water to drain downward and for the exterior cladding system to dry. At the base of the curtain wall should be weep holes that allow for water drainage. Opposite the exterior wall and across the air space is a continuous, water-resistant material adhered to the backup wall that forms the drainage plane.

Clogged/plugged weep hole (arrow)

2. Examine drip pans building-wide for corrosion/proper drainage and replace as necessary.
3. Remove blockages from affected weep holes to ensure proper operation of drainage plane.

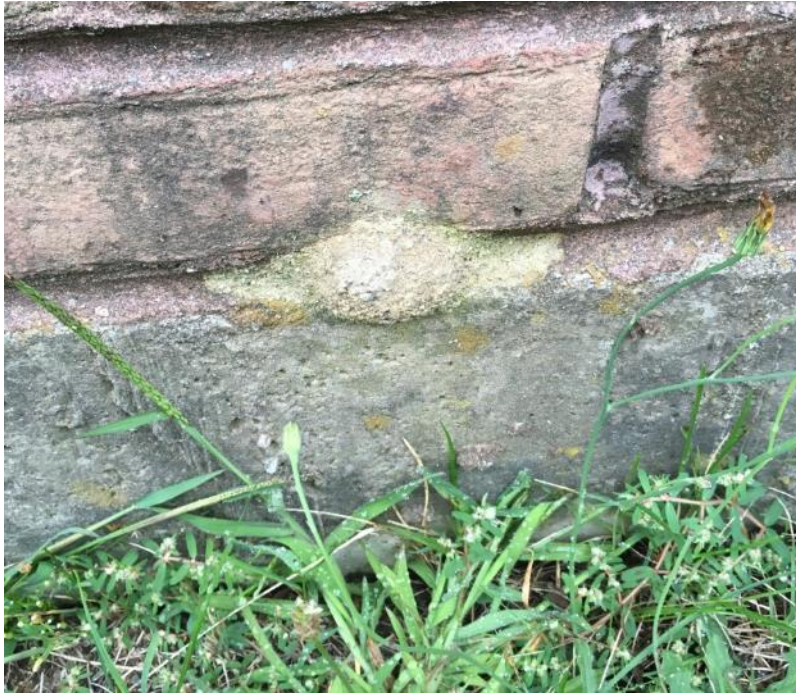
Picture 27

Clogged/plugged weep hole

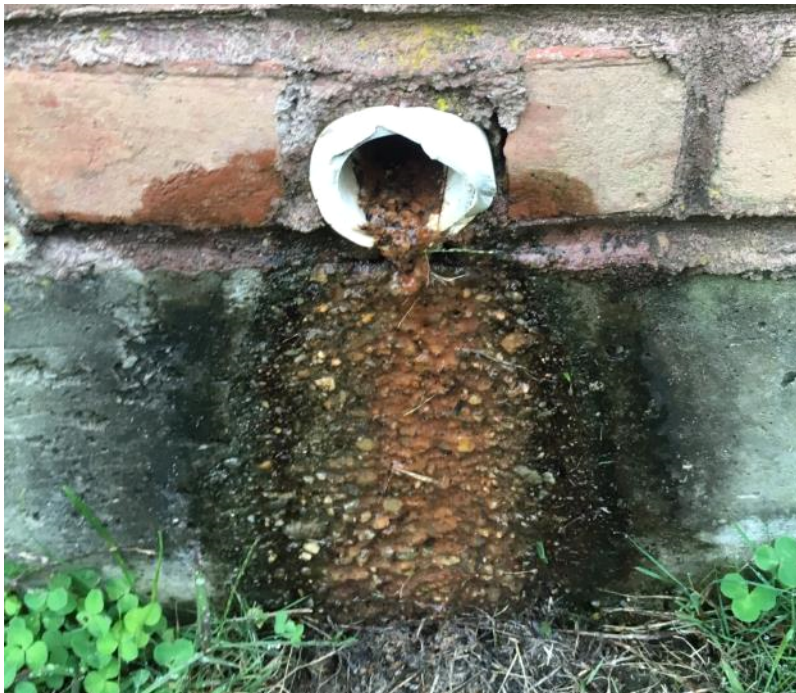
Picture 28

Also noted on exterior walls was the presence of rust-colored scale/debris from AC condensation pipes (Picture 28). This may indicate that metal drip pans are corroded/at the end of their service life. It is important that drip pans be smooth/clean and drain properly to prevent debris from clogging drain holes, which can lead to standing water and bacterial/mold growth and associated odors within units.

Debris/scale from condensate pipe/drip pans

23. Ensure that condensation from AC equipment is draining properly. Check collector pans, piping and any associated pumps for clogs and leaks and clean periodically to prevent stagnant water build-up and remove debris that may provide a medium for microbial growth.

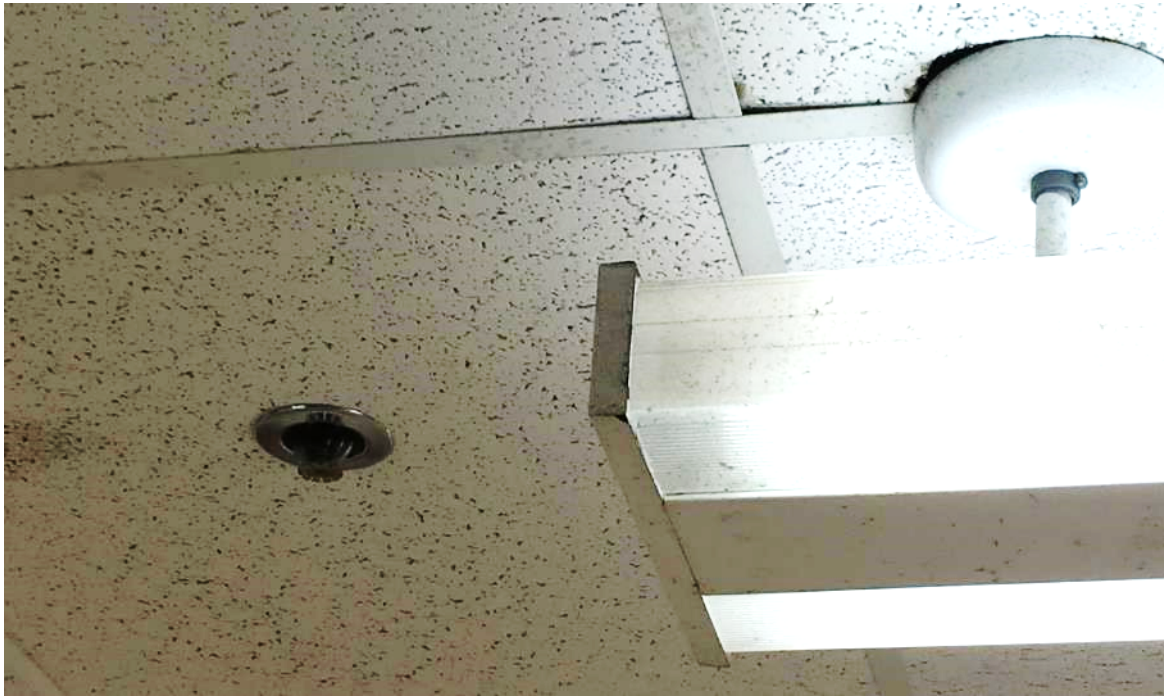
Picture 29

Dust/debris/staining on light fixture directly in front of univent, also note sprinkler head

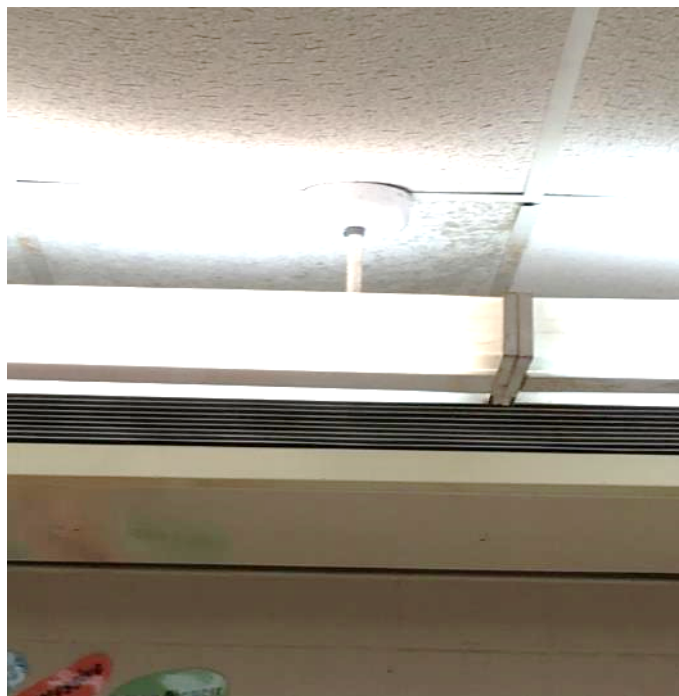
Picture 30

Suspended lighting fixture and stained tile in front of univent

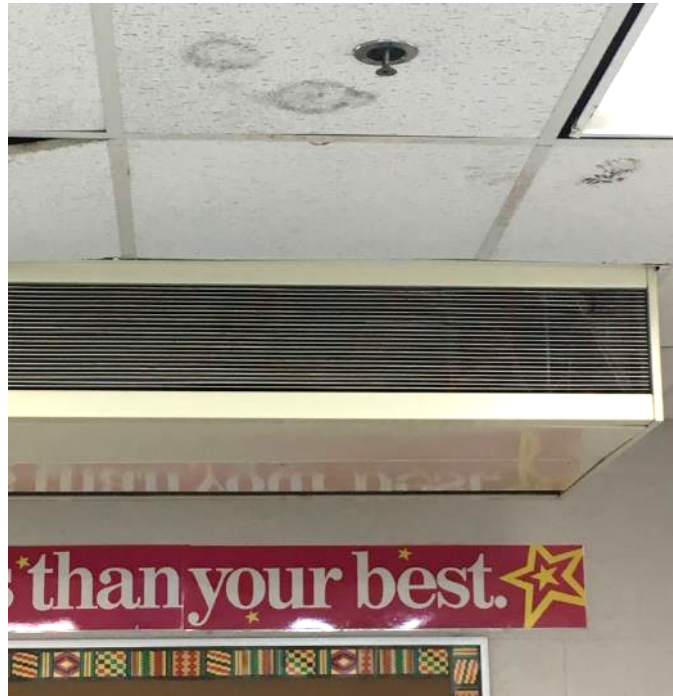
Picture 31

Water-damaged/moldy ceiling tiles and metal sprinkler head directly in front of univent

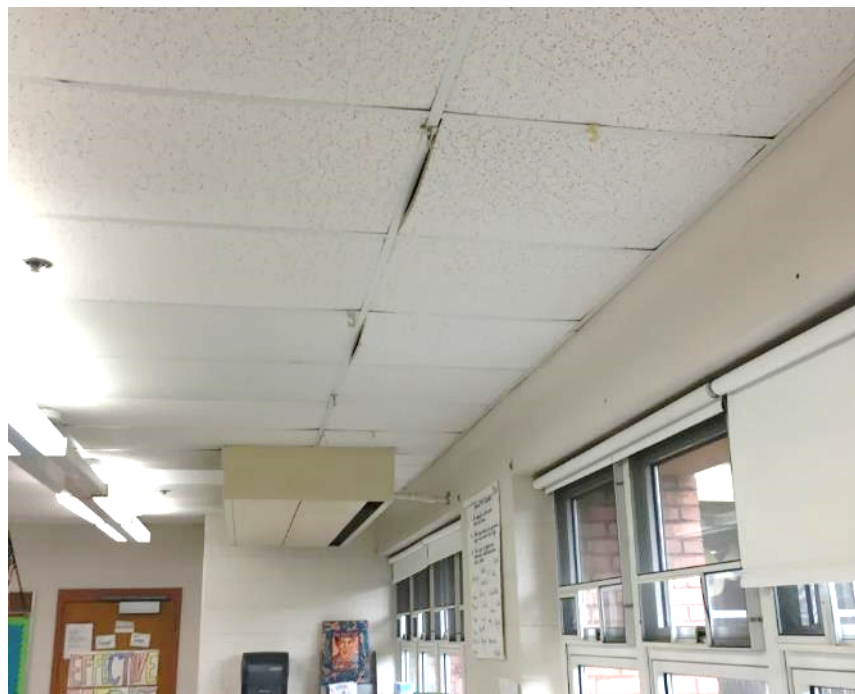
Picture 32

Of particular concern are weather patterns of high temperatures (heat waves) and elevated humidity conditions (> 70%) for extended periods of time (three/more consecutive days). If a building does not have either adequate exhaust ventilation and/or air chilling capacity to remove/reduce relative humidity from outside air, then hot, moist air can be introduced into a building and linger to increase occupant discomfort as well as possibly moisten materials that may lead to mold growth. The MDPH recommends a comfort range of 40 to 60 percent for indoor air relative humidity, which were exceeded throughout the building during the September 12th visit. Chronic issues with excess humidity were evident by the presence of “bowed” (i.e., non-flush) ceiling tiles throughout the building (Picture 32).

“Bowed” (non-flush) ceiling tiles in first floor classroom

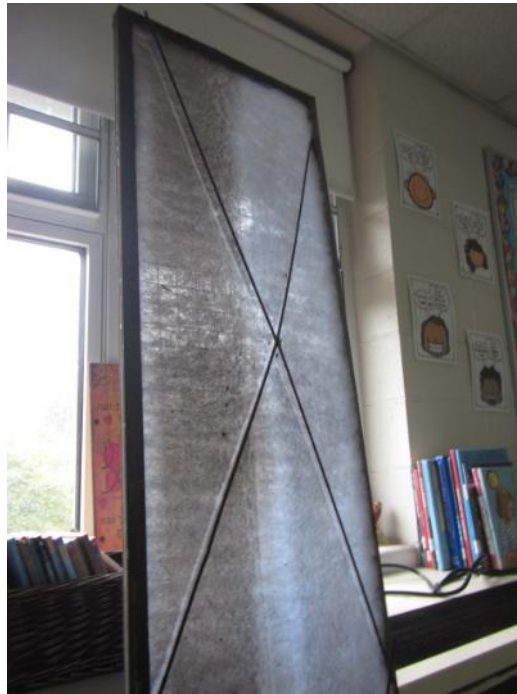
Picture 33

Metal filter rack and media that needs to be “cut to size” and installed in univents

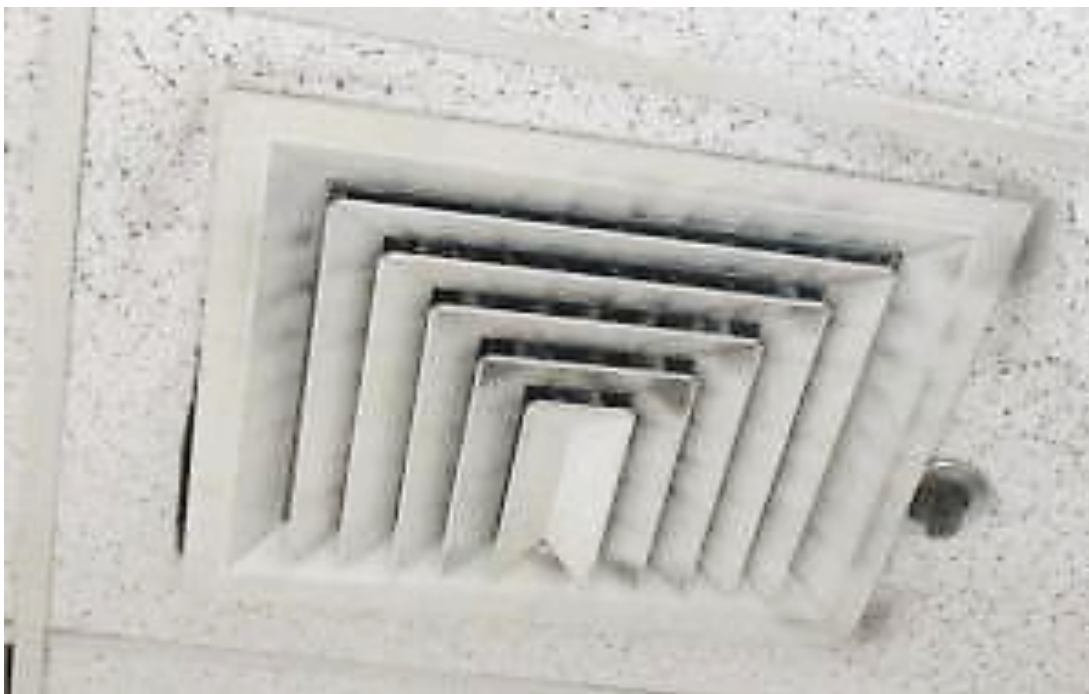
Picture 34

In some areas, exhaust vents, supply diffusers and the interior of univents had accumulated dust/debris (Table 1, Pictures 4, 34 and 35). This dust can be reaerosolized under certain conditions, and can also be a medium for mold growth. Univent cabinets can also accumulate dust and debris which should be cleaned when filters are changed (2-4 times/year).

Accumulated dust/debris on supply diffuser and surrounding ceiling tile
